**Flood Control Project Maintenance
Levee Inspections****LMA District Cover Sheet****Spring 2012 Levee Inspection Results****Sutter Maintenance Yard Nelson Bend**

Levee Inspection Report By Mile - Spring 2012

Sutter Maintenance Yard Nelson Bend

Waterway						Bank	Unit Miles	Inspection Start/End	Inspector
Unit No. 01 Feather River West Levee-Nelson Bend							0.50	03/27/2012 03/27/2012	Clay Thomas
LMR No.	Levee Mile		Category	Item	Location * + Rating	Action/Comment	GPS Latitude/Longitude		Issue No. Photo
	Start	End					Start	End	
1	0.01	0.45	Earthen Levee	Vegetation	WS M Ma	V2 : Remove the wild growth other than native grasses from the levee slopes.	38.886940 ° -121.614755 °	38.880855 ° -121.614555 °	2 Y
DWR ID: DWR_ST0006_01_s_2012_2									
2	0.01	0.45	Earthen Levee	Vegetation	LS M Ma	V2 : Remove the wild growth other than native grasses from the levee slopes.	38.886937 ° -121.614752 °	38.880822 ° -121.614565 °	1 Y
DWR ID: DWR_ST0006_01_s_2012_1									
3	0.01	0.45	Earthen Levee	Trim / Thin Trees	LS M Ma	T2 : Thin trees to allow visibility of the ground and room to flood fight.	38.886933 ° -121.614753 °	38.880857 ° -121.614555 °	3
DWR ID: DWR_ST0006_01_s_2012_3

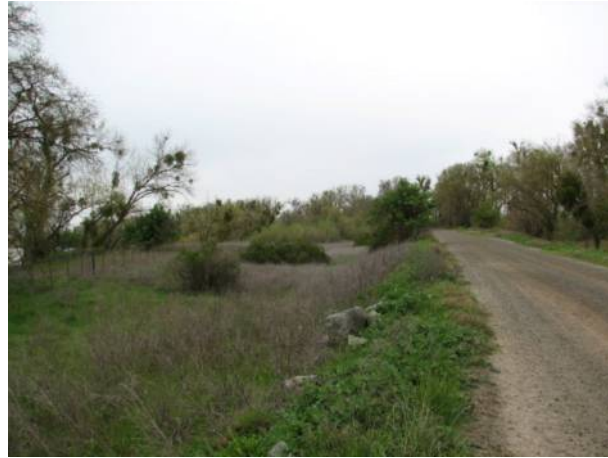
cathom_s_20120329_417.JPG

Levee Mile Report Line	1
Start Levee Mile	0.01
End Levee Mile	0.45
Location	Water Side
Category	Earthen Levee
Item	Vegetation

This photo was taken at levee mile 0.00 looking downstream at the waterside vegetation.

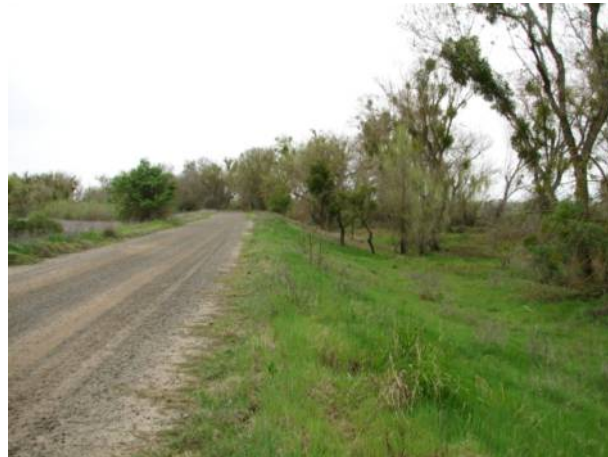
cathom_s_20120329_418.JPG

Levee Mile Report Line	2
Start Levee Mile	0.01
End Levee Mile	0.45
Location	Land Side
Category	Earthen Levee
Item	Vegetation

This photo was taken at levee mile 0.00 looking downstream at the landside vegetation.
